| Contractor | <b>Ask Us Drain Services LTD</b> |

## Inspection report

| Date:<br><b>24/09/2020</b> | Job N°: | Weather:<br><b>Rain</b> | Operator:<br><b>TEST</b> | section number:<br><b>1</b> | PLR:<br><b>FW MH 1 X</b> |

| Location: <b>Property with buildings</b> | Standard: <b>BS EN 13508-2:2003</b> | Total length: | <b>4.26 m</b> |

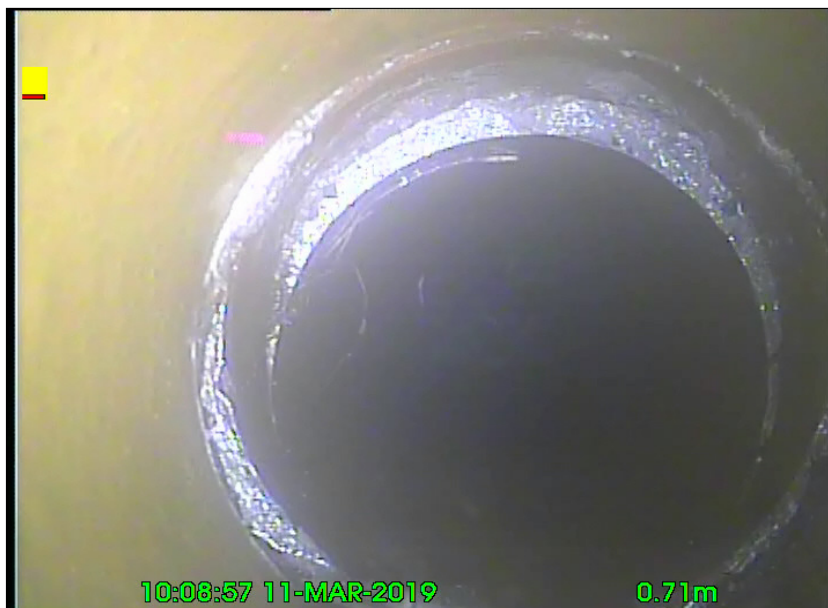
| 1:50 | position | code | observation | counter | photo | grade |
|---|---|---|---|---|---|---|
| | 0.71 | JDM | Joint displaced medium | 00:00:00 | 3_3a | (Struct) 1 |

Photo: 3\_3a, 00:00:00  
 0.71m, Joint displaced medium

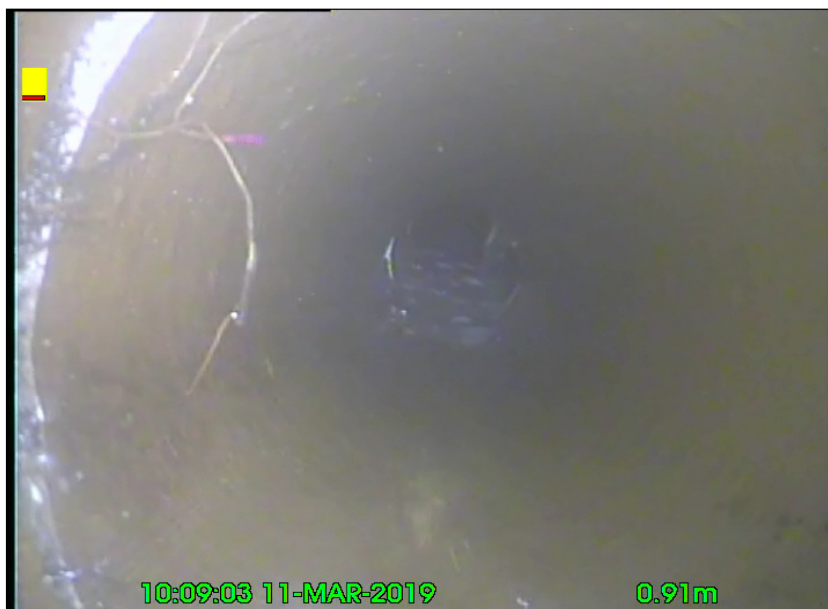
| 1:50 | position | code | observation | counter | photo | grade |
|---|---|---|---|---|---|---|
| | 0.91 | RFJ | Fine Roots at joint , from 09 to 11 o'clock | 00:00:00 | 4_4a | (Serv) 1 |

Photo: 4\_4a, 00:00:00  
 0.91m, Fine Roots at joint , from 09 to 11 o'clock

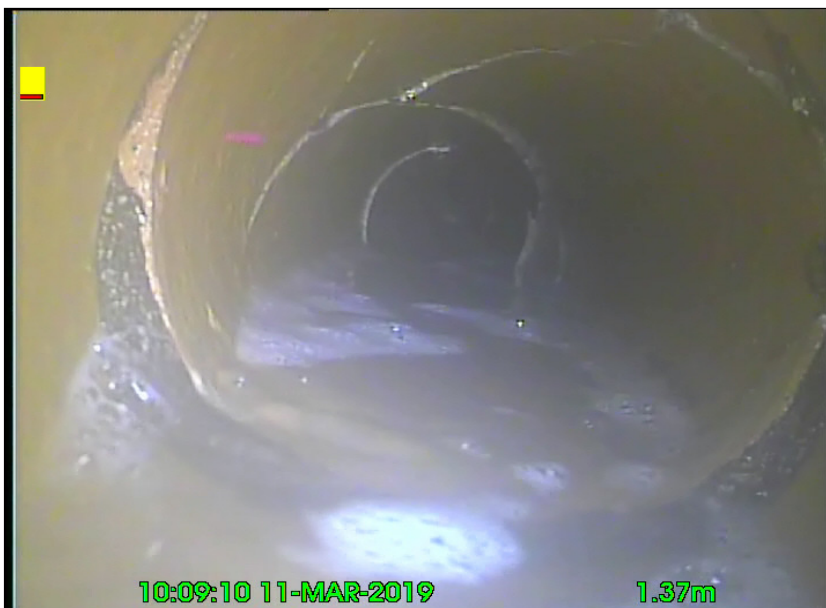
| 1:50 | position | code | observation | counter | photo | grade |
|---|---|---|---|---|---|---|
| | 1.37 | FM | Fractures multiple from 08 to 03 o'clock | 00:00:00 | 6_6a | (Struct) 4 |

Photo: 6\_6a, 00:00:00  
 1.37m, Fractures multiple from 08 to 03 o'clock

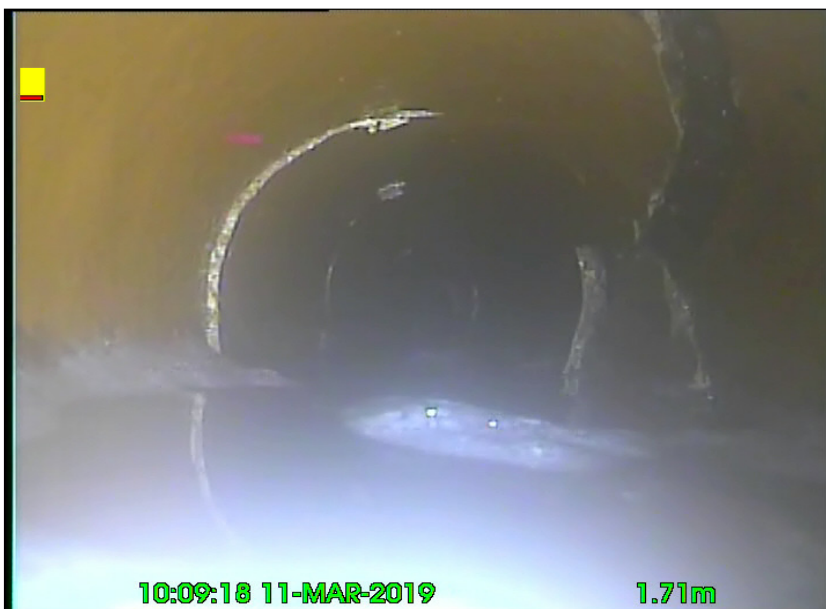
| 1:50 | position | code | observation | counter | photo | grade |
|---|---|---|---|---|---|---|
| | 1.71 | H | Hole in sewer from 01 to 05 o'clock | 00:00:00 | 7_7a | (Struct) 4 |

Photo: 7\_7a, 00:00:00  
 1.71m, Hole in sewer from 01 to 05 o'clock

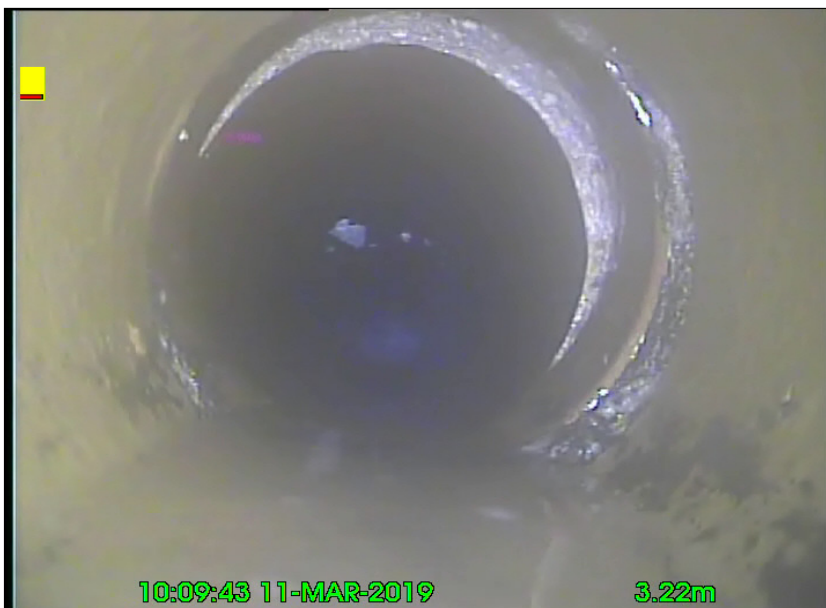
| 1:50 | position | code | observation | counter | photo | grade |
|---|---|---|---|---|---|---|
| | 3.22 | JDM | Joint displaced medium | 00:00:00 | 8_8a | (Struct) 1 |

Photo: 8\_8a, 00:00:00  
3.22m, Joint displaced medium

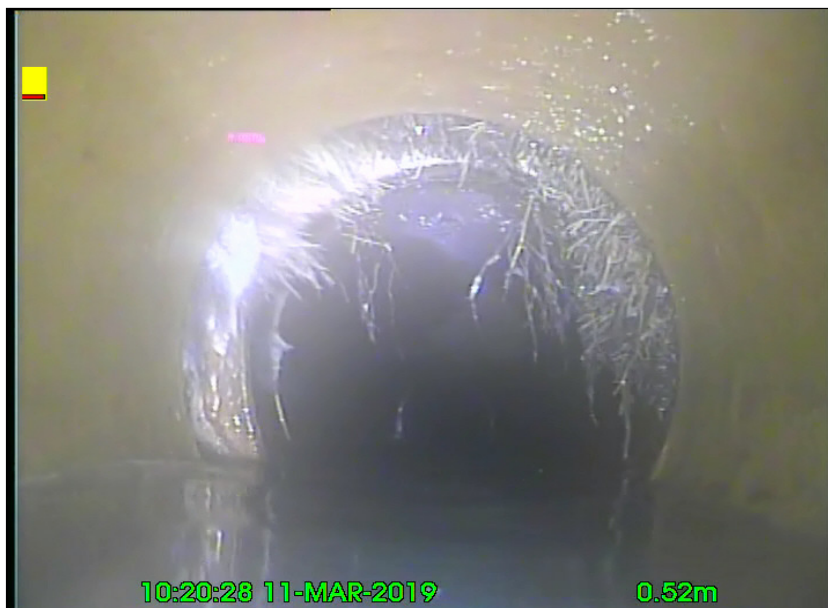
| 1:75 | position | code | observation | counter | photo | grade |
|---|---|---|---|---|---|---|
| | 0.52 | RFJ | Fine Roots at joint , from 07 to 05 o'clock | 00:00:00 | 13_5a | (Serv) 2 |

Photo: 13\_5a, 00:00:00  
 0.52m, Fine Roots at joint , from 07 to 05 o'clock

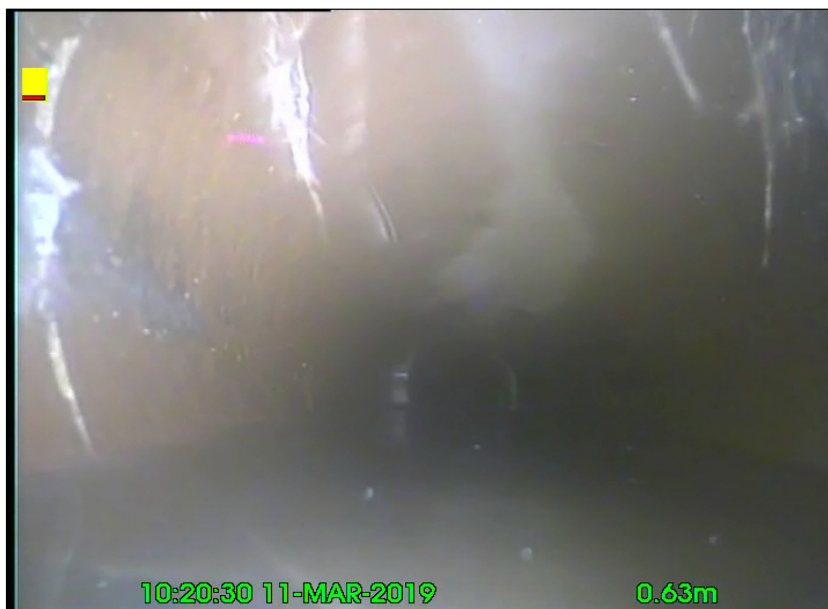
| 1:75 | position | code | observation | counter | photo | grade |
|---|---|---|---|---|---|---|
| | 0.63 | CC | Crack Circumferential from 07 to 11 o'clock | 00:00:00 | 15_6a | (Struct) 2 |

Photo: 15\_6a, 00:00:00  
 0.63m, Crack Circumferential from 07 to 11 o'clock

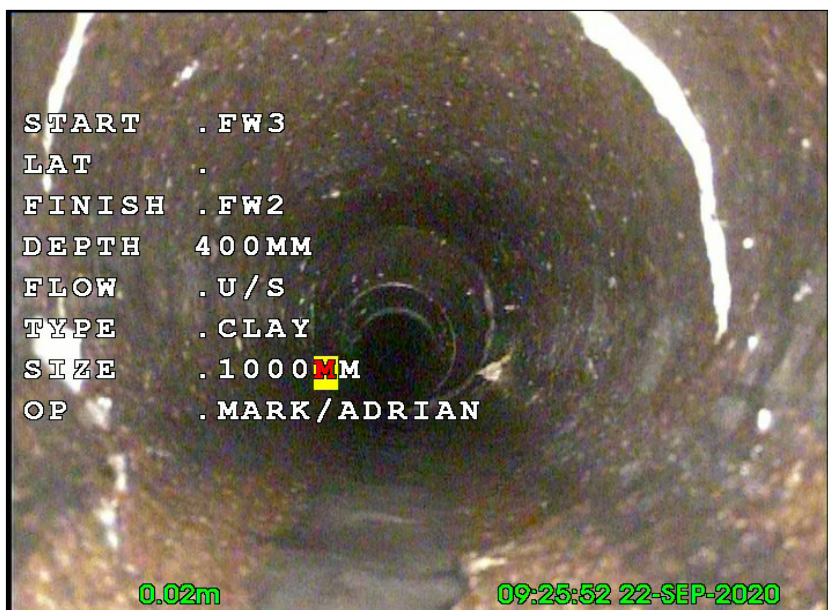
| 1:50 | position | code | observation | counter | photo | grade |
|---|---|---|---|---|---|---|
| | 0.02 | FC | Fracture Circumferential from 08 to 04 o'clock | 00:00:00 | 22_3a | (Struct) 3 |

Photo: 22\_3a, 00:00:00  
 0.02m, Fracture Circumferential from 08 to 04 o'clock

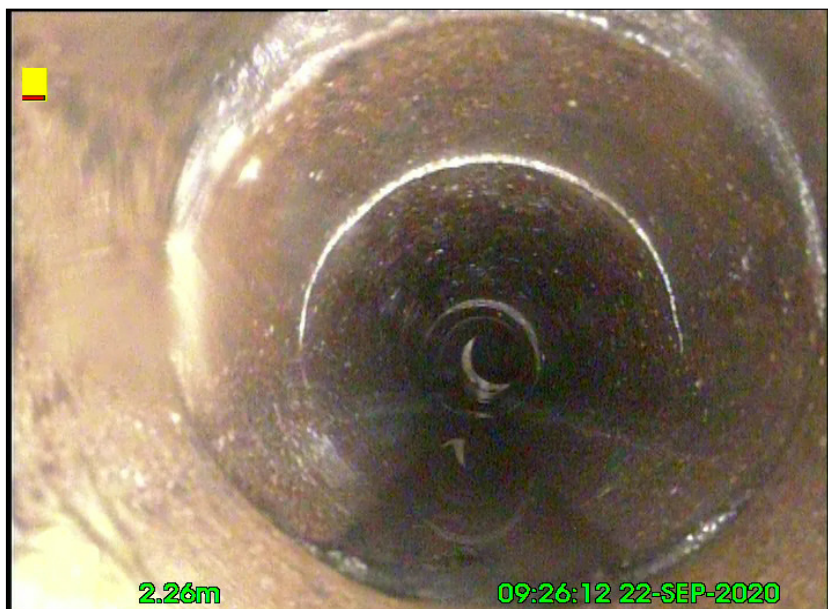
| 1:50 | position | code | observation | counter | photo | grade |
|---|---|---|---|---|---|---|
| | 2.26 | FC | Fracture Circumferential from 09 to 03 o'clock | 00:00:00 | 24_5a | (Struct) 3 |

Photo: 24\_5a, 00:00:00  
 2.26m, Fracture Circumferential from 09 to 03 o'clock

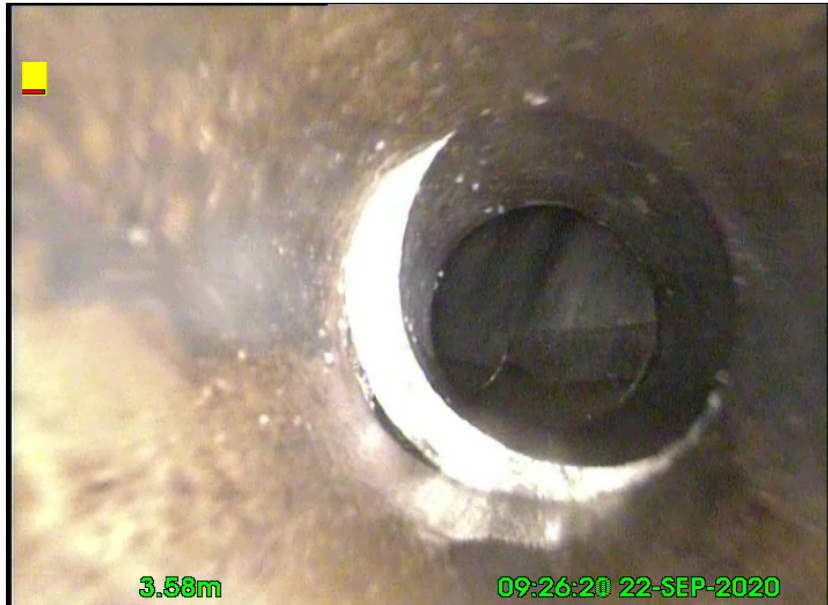
| 1:50 | position | code | observation | counter | photo | grade |
|---|---|---|---|---|---|---|
| | 3.56 | JDL | Joint displaced large, from 05 to 11 o'clock | 00:00:00 | 25_6a | (Struct) 2 |

Photo: 25\_6a, 00:00:00  
3.56m, Joint displaced large, from 05 to 11 o'clock
